HSV Public Services Report June 16, 2021

Chair of the Public Services Committee, Philip Matone, presented the quarterly report to the Hot Springs Village Property Owners' Association Board of Directors at the June 16, 2021 Board Meeting.

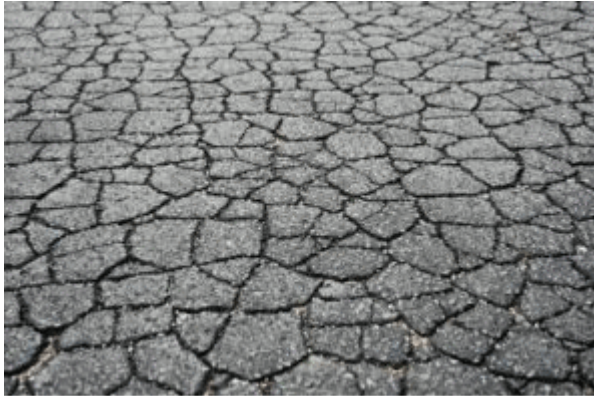
Example of alligator cracking (photo is NOT from HSV and is for illustrative purposes, only)

Matone said, “this happens to be an area where I worked for about 40 years [he is referring to road work].” {Matone showed a photo of Agua Vista Lane.) “If you can see the cracking..., that is called ‘alligator cracking,’ because it kind of looks like an alligator’s back. When we get that situation, it is strongly indicative that the material under the base and the road, called the subgrade, have excess moisture in it and will no longer support the road. We have no choice when we hit this level of deterioration, except to core it out – take all the material out – take it down to where we hit the solid ground (subgrade).”
